# Manhole Inspection Summary

Manhole # S01EE2031MH

**Location** Address: **6406 CROSS COUNTRY BLVD** Cross Street: **BANCROFT RD**

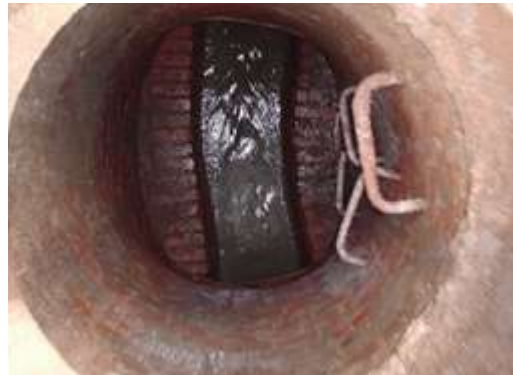
Top View

Comments **Top View picture indicates evidence of infiltration.**

**Chimney / Frame Adjustment** ☒ Exists Material: **Brick** ☐ Parged Height: **2** (in.)  
Condition: ☒ Sound ☐ Cracked ☐ Root Intrusion ☐ Loose Brick ☐ Deteriorated  
Infiltration: ☐ None ☐ Joint ☐ Cracks ☒ Mortar ☐ Roots ☒ Wall

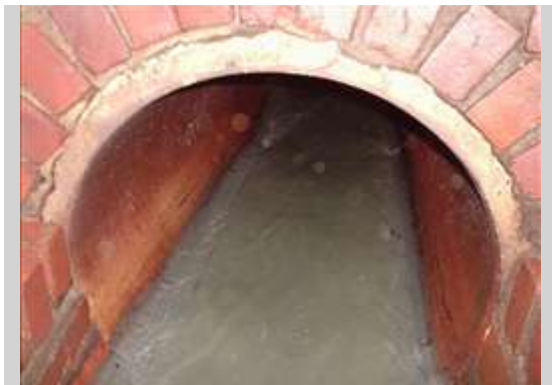
Pipe Out @ 12 O'Clock

Infiltration: **Weeper** Pipe Seal Cond: **Cracked**

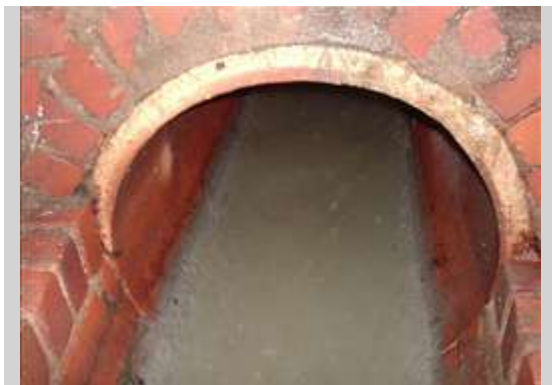
Pipe In @ 6 O'Clock

Infiltration: **Evidence** Pipe Seal Cond: **Sound**
